THE FLOODING OF WESTERN DEEP LEVELS NO.1 SHAFT

R. L. de G. SOLMS

MINE MANAGER, WESTERN DEEP LEVELS LIMITED (SOUTH)

WESTERN DEEP LEVELS LIMITED (SOUTH)
FLOODING/DE-WATERING NO.1 SERVICE SHAFT

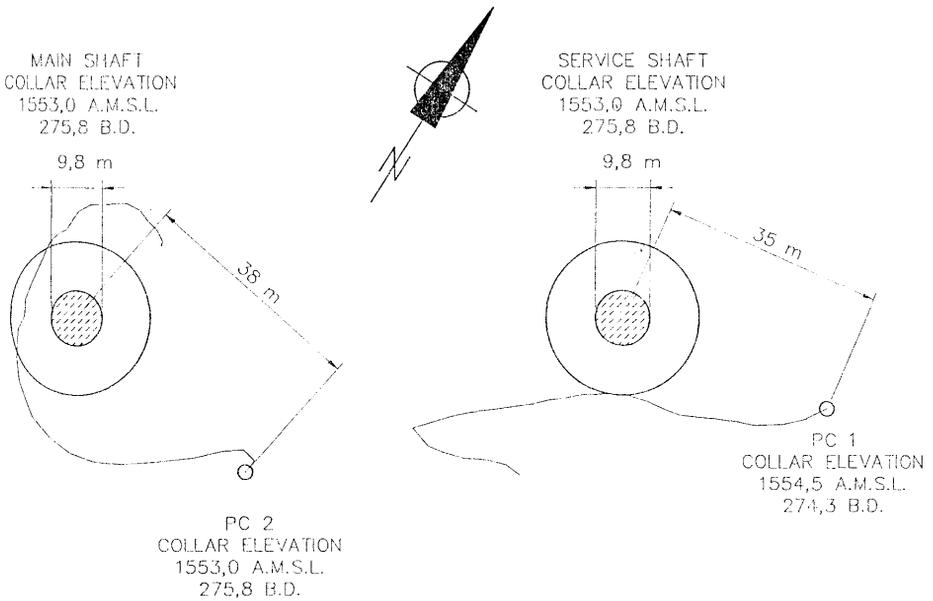
FIGURE 4

The pre-cementation rigs were mounted 35 metres from the centre of each shaft to permit headgear foundation excavations to be done concurrently with drilling operations. The intention was to spiral the holes in a clockwise direction round the shaft for maximum cover. In practice this was not achieved, as illustrated in Figure 4.

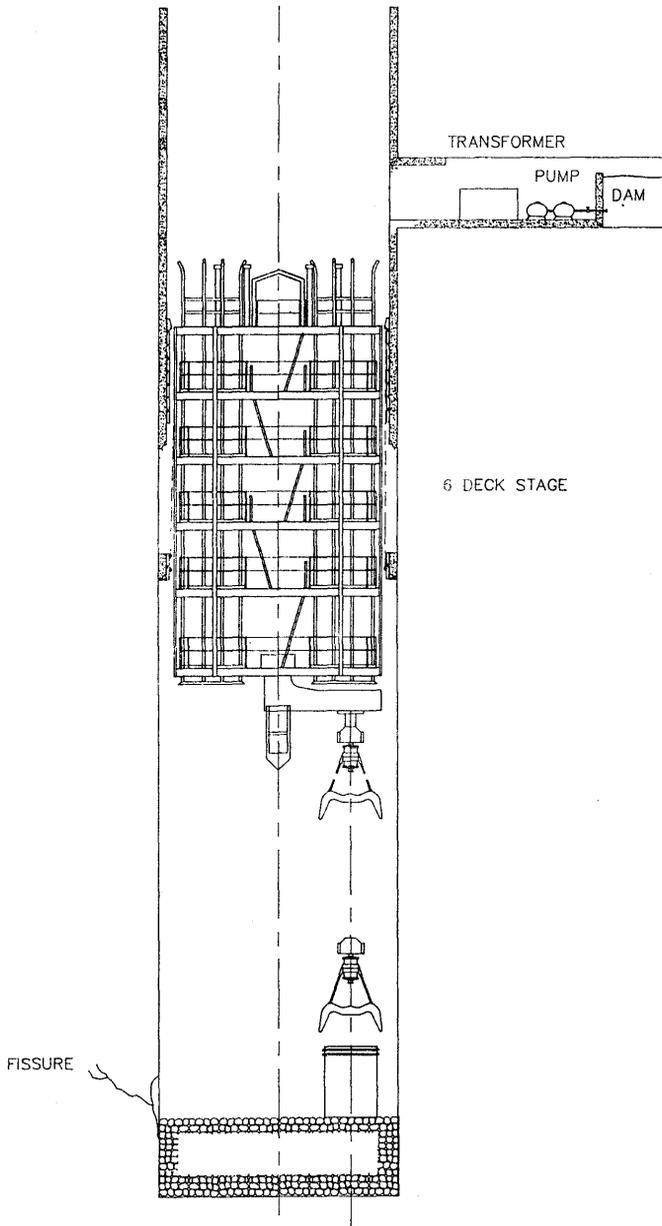
FIGURE 11

On the night of the 9th July, 1982, when the shaft was at a depth of -970 metres below collar and while preparations were being made to lash a blasted round, a long slab of the sidewall approximately 3 metres long and 2 metres in height broke away and partially heaved over in the shaft. See Figure 11.

9: 30 pm FRIDAY 9th JULY 1982

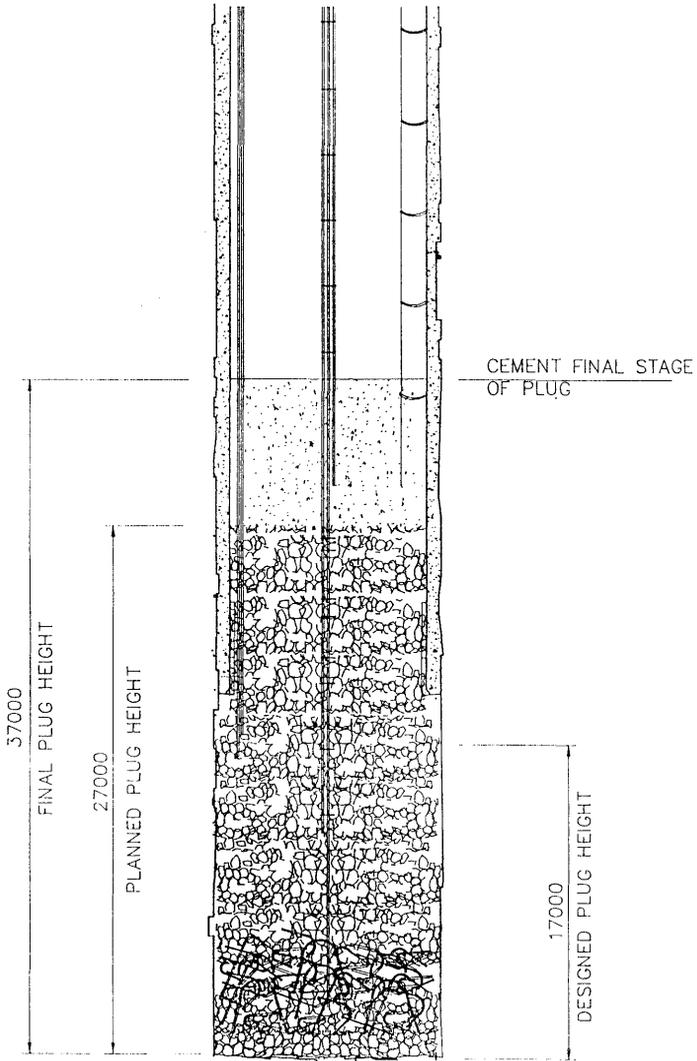
FIGURE 13

SECTION THROUGH PLUG AS PLANNED

In constant discussion with the Project Team and as many experienced 'experts' as was possible, they finally commissioned the Civil Engineering Department at the Witwatersrand University to design the plug. Professor Blight determined that a plug of 17 metres length in the 10 metre diameter shaft would have a safety factor of 5:1 even if the plug strength was no greater than 5MPa. Because he assumed a homogeneous shaft lining and had to consider only a theoretical solution, Mine Management decided to increase the plug length to 27 metres, leaving nothing to chance. See Figure 13.

fact the 'B' ranges and the first 25mm ranges were persevered with until they blocked, before switching to the next set of ranges. To be sure that the plug was effective over its full length, pumping continued even after the top of the plumbs had been covered. See Figure 13.

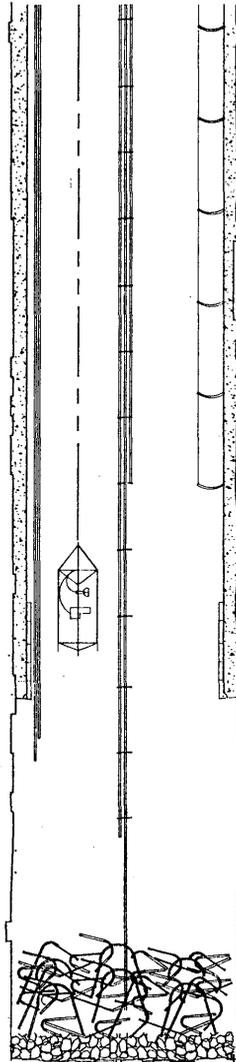
FIGURE 15

The De Beers off-shore operation (Marine Diamonds) offered the use of an underwater camera that could also be lowered to 600 metres below the water surface. After great frustration and many attempts the camera was finally able to provide the following information:- See Figure 15.

- a) The pipes were all contained in the bottom 11 metres of the shaft.
- b) The visibility in the water was too poor to risk the retrieval of the pipes by the divers.
