THE FLOODING OF WESTERN DEEP LEVELS NO.1 SHAFT

R. L. de G. SOLMS

MINE MANAGER, WESTERN DEEP LEVELS LIMITED (SOUTH)

WESTERN DEEP LEVELS LIMITED (SOUTH)
FLOODING/DE-WATERING NO.1 SERVICE SHAFT

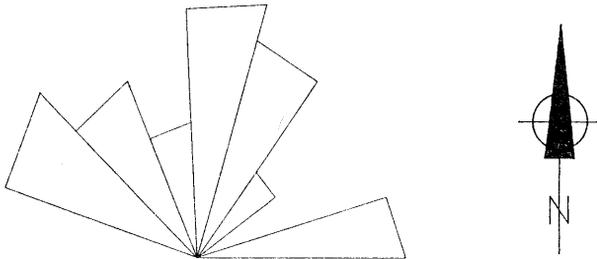
FIGURE 3

Jointing in the dolomite is not closely spaced and is rarely cemented by secondary calcite. The open joints offer a liberal interconnecting network in several directions as indicated by the rosette in Figure 3. This explains the rather haphazard intersection of water in the shaft cover drilling with a tendency to favour the principle north-south joint direction.

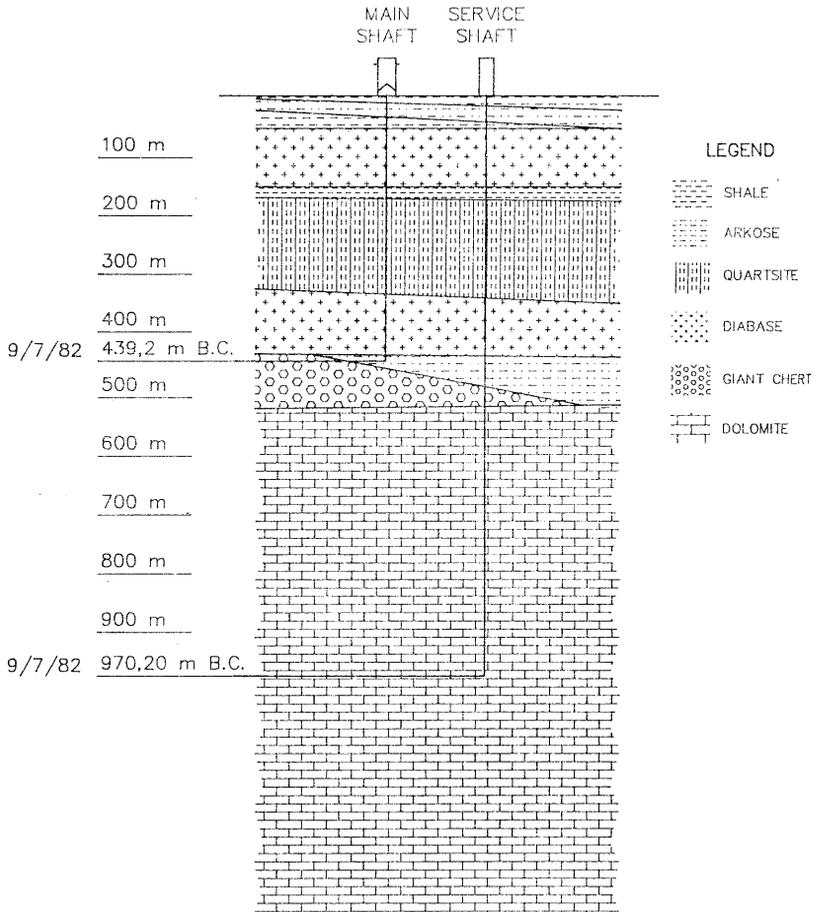
FIGURE 5

The geological sequence for the shafts is as follows:- See Figure 5.

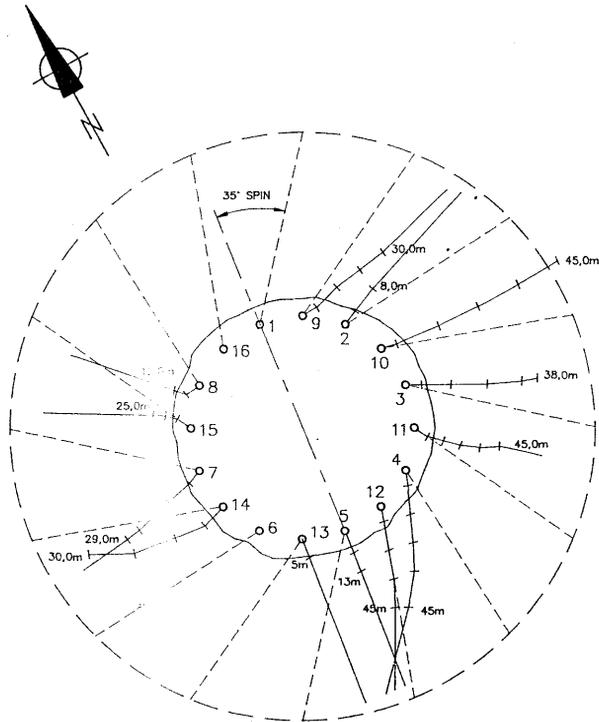
No.1 MAIN SHAFT COVER HOLE LAYOUT (1) DEFLECTIONS BEFORE USE OF RIG

Considering the vertical nature of the fissure and the amount of deflection of the cover holes, it is understandable that they failed to detect the fault.

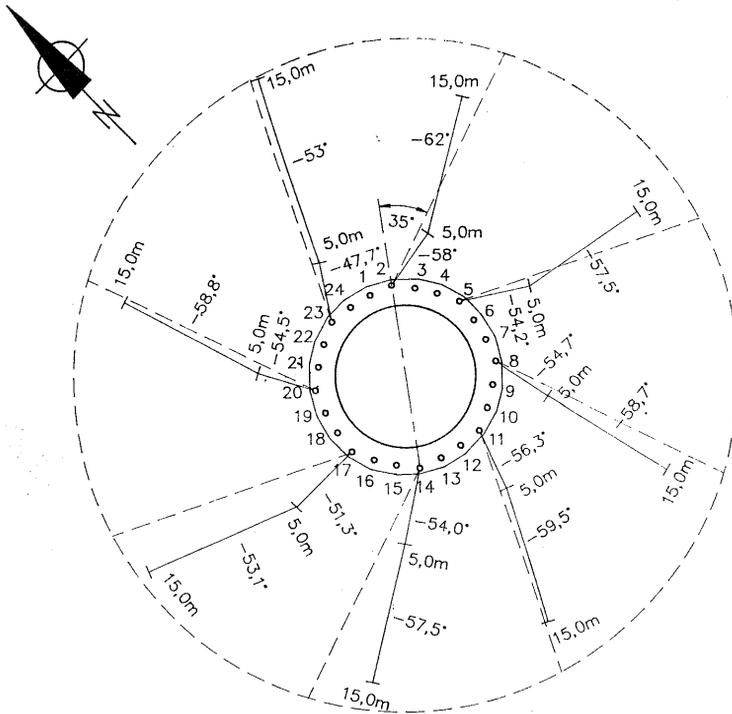
FIGURE 10A

No.1 MAIN SHAFT COVER HOLE LAYOUT (2)
DEFLECTIONS OBTAINED USING DRILL RIG
